Diagnosis, restoration and consolidation's quality control of columns and capitals in "Nostra Signora delle Grazie" sanctuary - Imperia (Italy)

DARIO ALMESBERGER^{1*}, ANTONIO RIZZO¹, RAFFAELLA GEOMETRANTE² and MARCO RIZZO¹

¹ SER.CO.TEC. S.r.l. – Piazza S. Giovanni 3 – Trieste – Italy

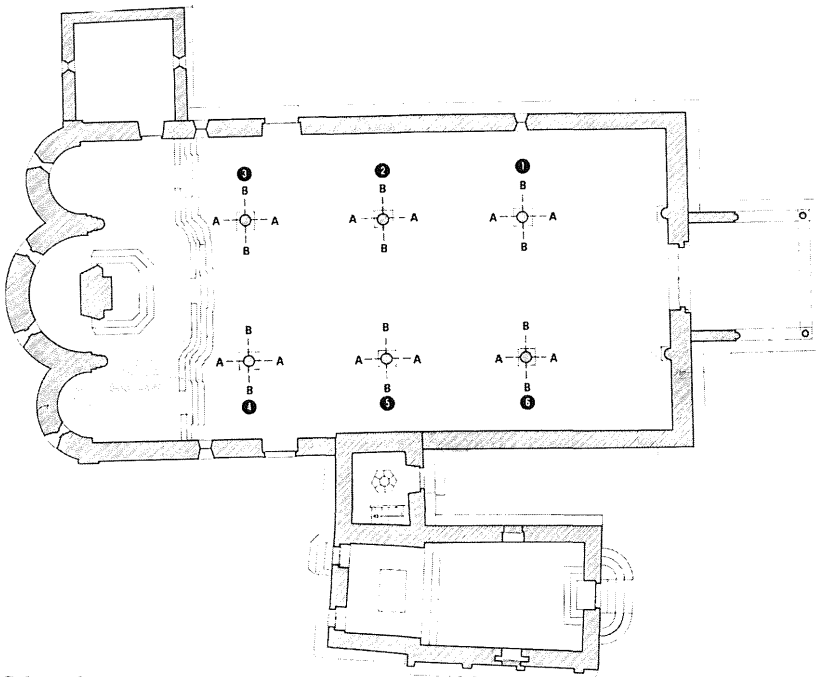
Fig. 2 – Colonnade

A limestone colonnade (Fig. 2) constitutes one of the most relevant part of this construction. On some of its columns and capitals, superficial and crossing cracks are present, probably due to thrust and peak loads or because of non-uniform distributions of stresses driven by overhanging elements.

On that column where the worst deterioration is present (identified by number 6 - Fig. 2), scaling and detachment plates are evident. Capital and stone footing of the same column are deeply damaged. In particular on the stone footing, scaling and delamination processes have developed because of the crystallisation of salts brought by capillary raise humidity or present in the stone composition. Generally, the formation of salt crystals takes place with volume increasing which generates inner stresses similarly to those caused by the transformation water to ice. This phenomenon depends on the number of evaporation and saturation cycles, on stone porosity and on the condition of water priming and superficial evaporation.

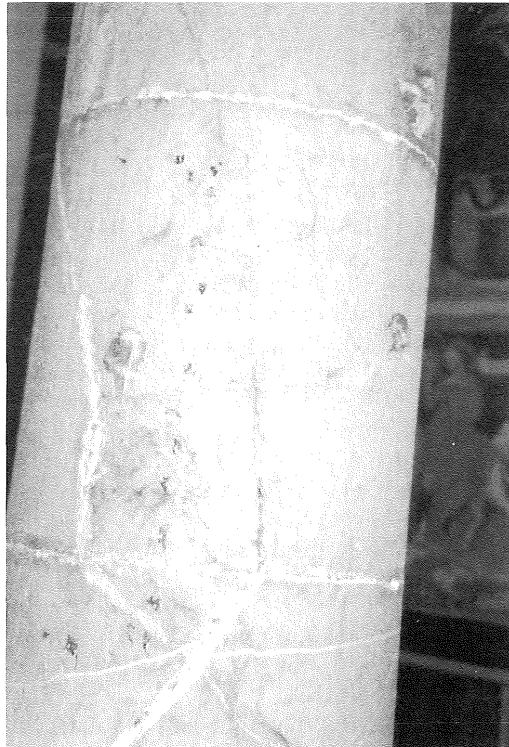
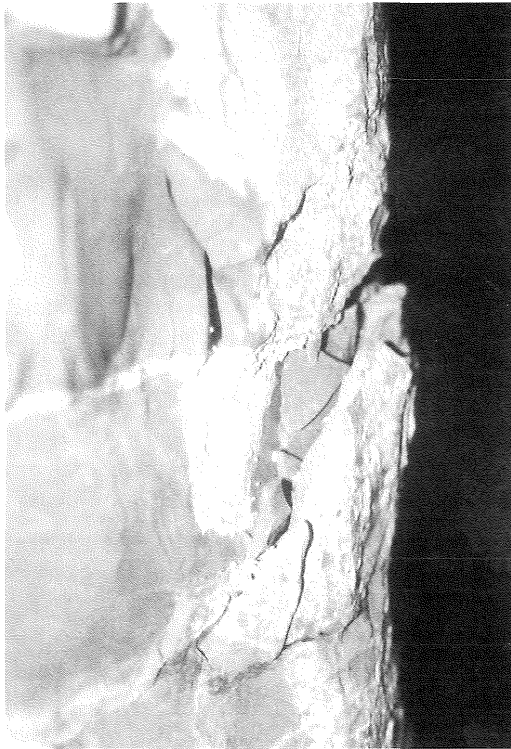
Fig. 3 – Particular of column 6

The non-destructive survey carried out on this column has pointed out its severe decay and deterioration (Fig. 3 and 4).

Important flanking and delamination were evident on the footing stone, surely due to the capillary rise which transports sulphates from the soil. Sulphate, in addition to moisture, may develop ettringite and thaumasite, two very well-known compounds in Portland cement chemistry. However, they can also form in the materials of historical buildings constructed before Portland cement was discovered. Both the formation of ettringite and that of thaumasite appear macroscopically through swelling of the original material that can scale or be reduced even to pulp when thaumasite is produced⁷. Volume's increase develops extremely dangerous stresses inside the material causing, in some cases, its destruction.

The two lower segments of the column have been substituted because of the severe damages (plate detachment and stone flaking) caused by past earthquakes and scarce jointing mortar.

Possible solutions were the complete substitution of the footing stone or a delicate work of «prosthesis» with an epoxy mortar and filler of the same stone.

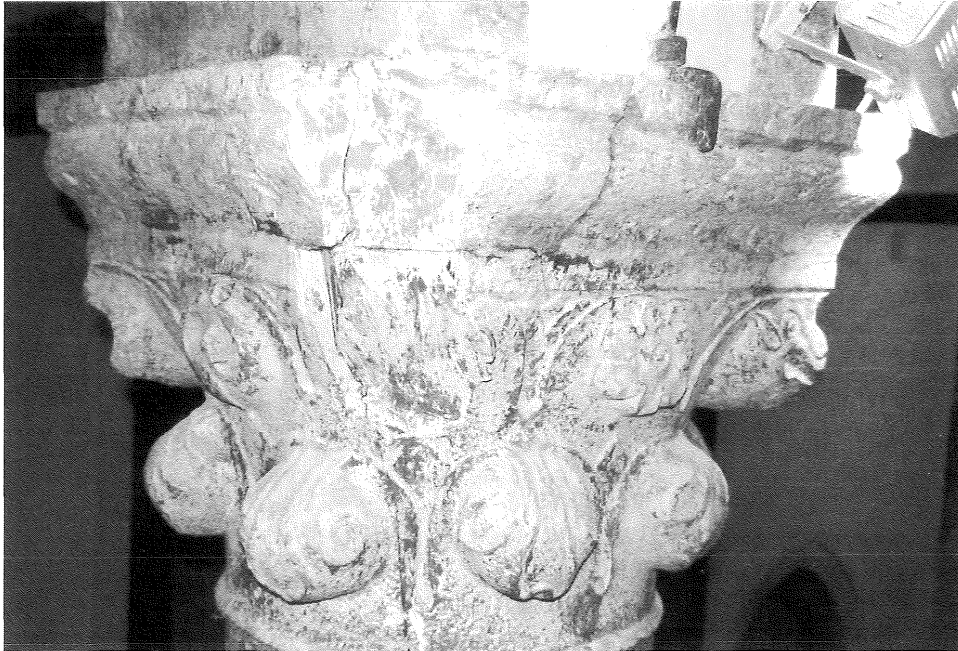
Fig. 5 – Capital of column 6

The capital was in very bad conditions with crossing cracks such to require a special intervention (Fig. 5).

In the case of the capital sixth column (Fig. 5), element particularly damaged, the application of stainless steel pins with

improved adhesion ('REVAL 31' Δ 10mm bars) has been necessary (Fig. 6). In the middle of detached parts, a 12 mm hole has been obtained; the bar has been inserted inside it.

Each pin, shaped both to assure good adherence and to allow a possible removal without excessive damage, is fixed by the epoxy resin PIT COLOR 902, in this case used as a structural adhesive. Moreover, this resin exerts a protective function on the metal, avoiding the contact with water which could move through stone porosity.

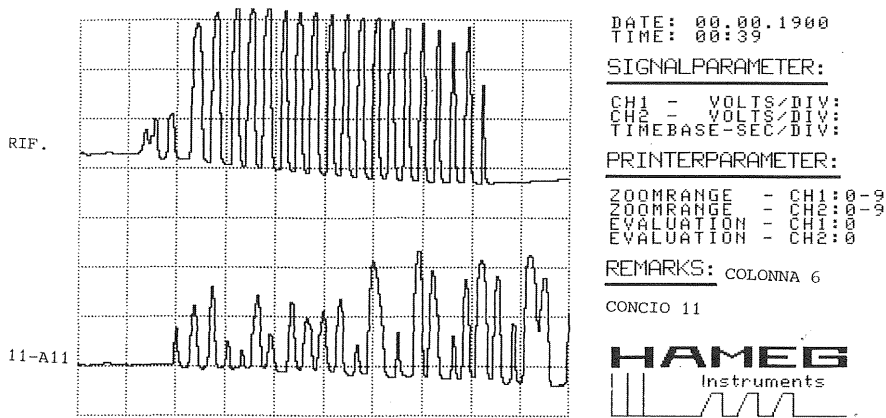
Fig. 7 – Example of oscillograph before consolidation

In Fig. 7 and 8, two of the numerous oscillographs recorded on column 6 in deteriorated and restored conditions are reported. In Tab. 2, part of the ultrasonic data measured on the same column is presented. In both cases an evident improvement is evident.
