SEM-XRD investigation of deterioration morphologies and consolidation prior to restoration: the case of Porta Nuova in Ravenna (Italy)

ABSTRACT - Porta Nuova in Ravenna (Northern Italy), built in the XVI century, has been the object of an interdisciplinary study, comprising an architectural survey of the Gate, mapping ashlar stones and drawing thematic maps. The following ornamental stones have been identified: Pietra d'Istria, Rosso Ammonitico Veronese, *Marmor Proconnesium*, *Marmor Troadense*, Pietra di Prun and Trachite dei Colli Euganei. Among these, *Marmor Proconnesium* and *Marmor Troadense* could be ancient materials recovered from monuments of Roman age.

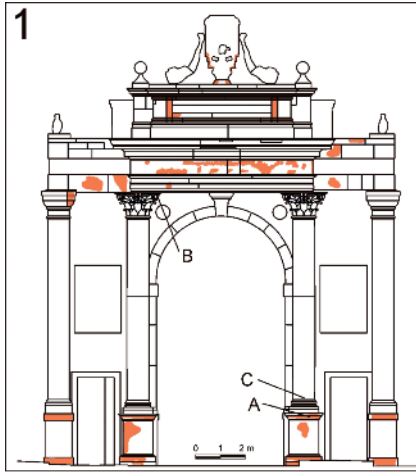
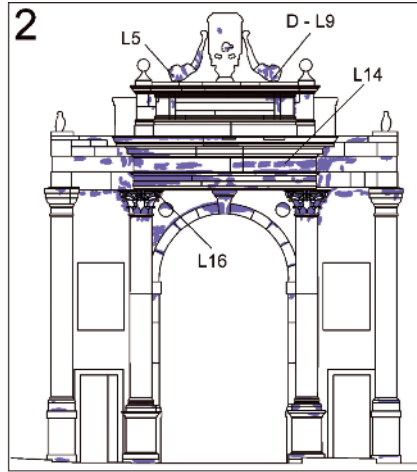
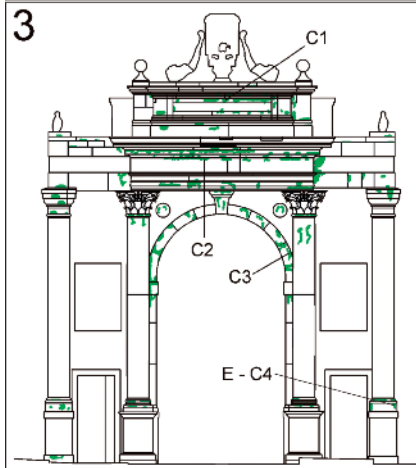
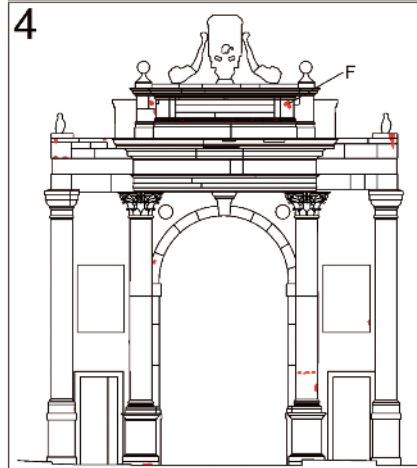
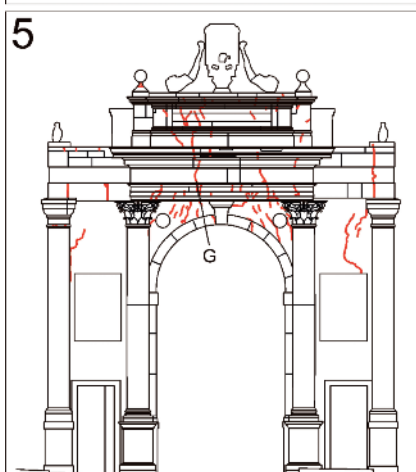
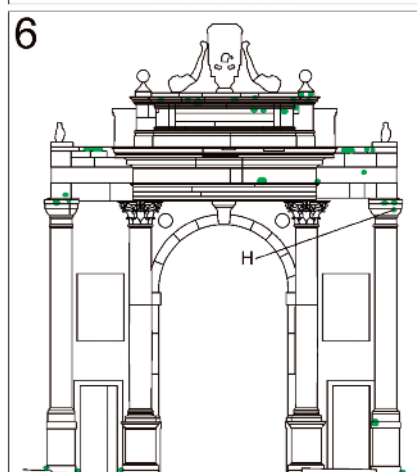
One of the materials that suffered major deterioration is the Rosso Ammonitico Veronese limestone, which shows diffuse detachment of nodular portions. This kind of deterioration is less evident on vertical surfaces, whereas it is particularly enhanced on the projecting and finely finished elements (Fig. 2-1-A and Fig. 3-

A). The nodular structure represents an intrinsic property of this limestone and the presence of matrix between the nodules has favoured the detachment as a consequence of stress caused by cycles of freezing and thawing of interstitial water and sudden temperature changes. The nodular and inter-nodular portions present a different degree of compactness and cementation. Therefore humidity and chemical and biological agents while favouring the detachment of the first, easily crumble the latter. Differential deterioration is particularly enhanced also on Marmor Proconnesium above all on ashlar corners and on capitals, where the surficial decohesion with detachment of calcite crystals is associated to fractures penetrating the marble. The surface decay and erosion can also be appreciated on limestone “vacuolar” (Fig. 2-2-D and Fig. 3-D) where we assist to consumption of the cornucopias fruits.

Exfoliation is particularly enhanced on the Marmor Troadense columns (Fig. 2-1-C and Fig. 3-C), with formation of surface sub-parallel flakes, often followed by detachment of the exterior part and consequent reduction of the column diameter. The single fragments (flakes) show a series of inter- and intra-granular fractures. This kind of deterioration can be ascribed to different causes, among which thermal shocks (particularly in the sun exposed zones) and the rock processing (all the ornamental stones were carved perpendicularly to the surface, which favours the following detachment of flakes, cf. Lazzarini, 1987). Contour scaling can be also observed at the base of the Marmor Troadense columns. Here, maximum humidity and static load occur where the columns lean on the stylobate.

Another major deterioration morphology reported for Porta Nuova is the formation of cm-thick black crusts that cover the material surfaces and are mostly developed on the undercut surfaces protected by washing away rain (Fig. 3-B and Fig. 3-D).

Fig. 3 - Macrophotographs of the main deterioration morphologies. Differential deterioration of Rosso Ammonitico Veronese (A), *Marmor Proconnesium* (B), *Marmor Troadense* (C), limestone "vacuolar" (D). Black crusts *Marmor Proconnesium* (B), limestone "vacuolar" (D). Oxalate films, limestone "facies liburnica" (E). Rust spots between Pietra d'Istria-Orsera and limestone "nodular" (F). Fracture systems along the Rosso Ammonitico Veronese and the Pietra d'Istria-Orsera (G). Vegetation (fern *Asplenium trichomanes*) between two elements of the limestone "facies liburnica" (H).

Our results present a proposition of conservation treatments that are in agreement with recent works (Lazzarini *et al.*, 2007) and can be extended to other case studies. First of all, conservation treatments need preliminary laboratory analyses to find out the best materials for the type of stones used in the monuments. Then deteriorated stones should be in principle structurally consolidated with ethyl silicate, which can glue the loose particles and thin sheets of powdering and flaking stones. Where heavy flaking occurs, epoxy resins should be used to bridge together two parts of a flake. All these

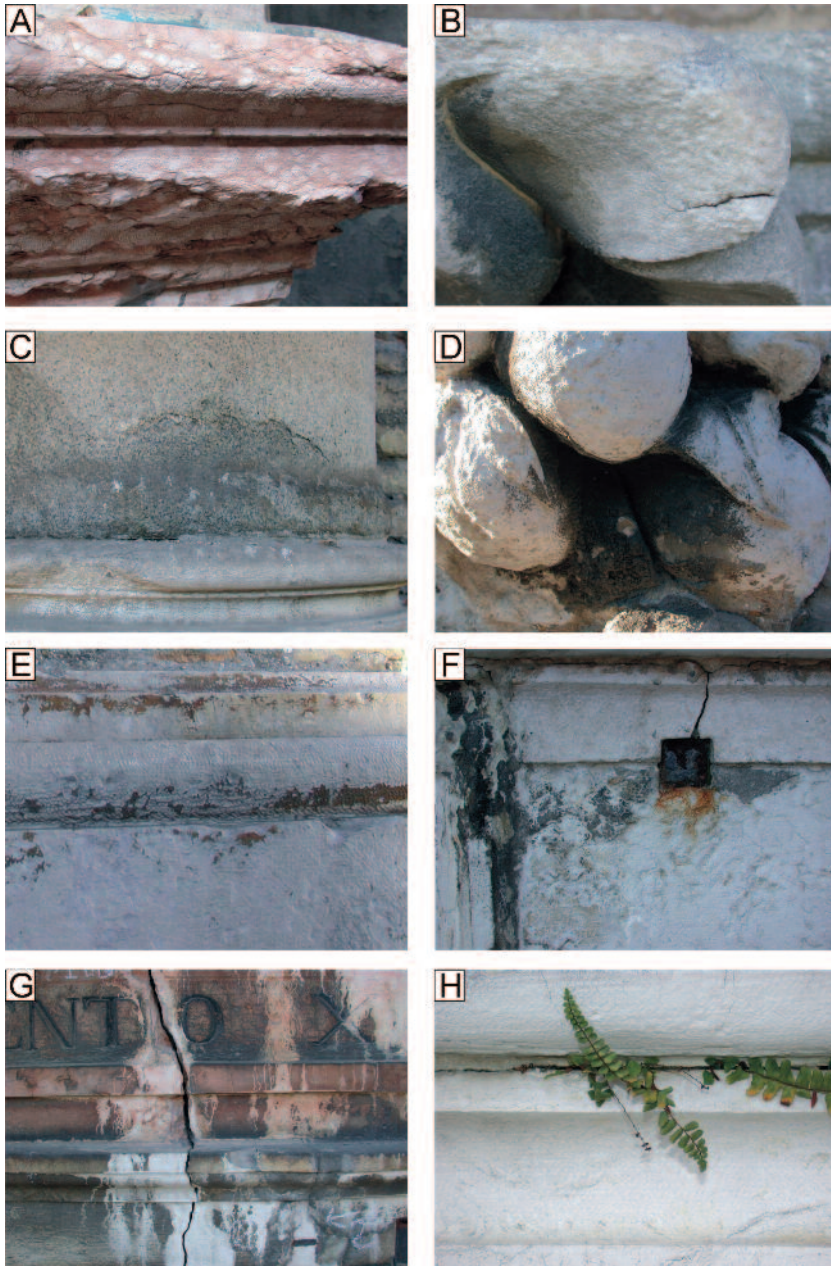
Fig. 2 (front page) - Schematic sketch of Porta Nuova front with the distribution of the main deterioration morphologies. 1- Differential deterioration. 2- Black crusts. 3- Oxalate films. 4- Rust spots. 5- Fracture systems. 6- Biological patina and vegetation. A, B, C, D, E, F, G, H location of the macrophotographs of figure 3. C1, C2, C3, C4 location of the specimens of Ca oxalates analyzed by XRD, figure 6. L9, L14 location of the specimens of black crusts analyzed in XRD, figure 5. L5, L14, L16 location of the specimens of black crusts analyzed by SEM-EDS microscopy, figure 4.

cramps, clamps and iron nails fixed by molten lead have often been employed. The oxidation of these elements has brought to the formation of iron oxides with consequent volume increase. Main consequences are stone fractures around swelled metallic elements and disfiguring rust spots often percolating below the rusty iron (Fig. 2-4 and Fig. 3-F).

XIX century. The walls demolition, in the first half of the XX century, caused a loss of lateral supports. Vibrations and shocks produced by the movement of heavy goods vehicles, brought to fracturation of the main supporting elements of the Gate. The fracture system (Fig. 2-5 e Fig. 3-G) in turn led to a progressive subsidence and bending of both the arch and the architrave, yet overloaded by the overlying attic.

On Porta Nuova stones has not been reported the occurrence of lyophilic lichens. Their disappearance has likely to be related to the air quality that in the historic centre of Ravenna is particularly polluted. The mapped weeds are represented almost exclusively by *Parietaria officinalis* L., whose roots grow within the joints of ashlar stones. The presence of the fern *Asplenium trichomanes* (Fig. 2-6 and Fig. 3-H) has also been detected. Green algae and moss have been observed in humid areas.

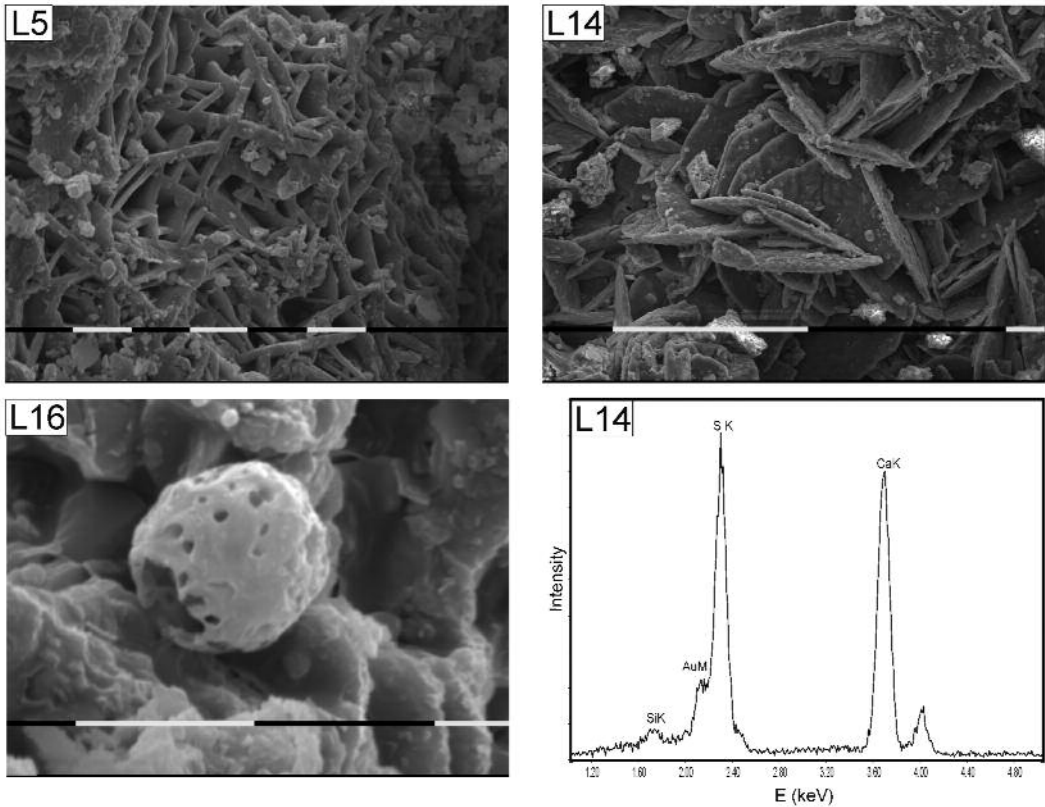
Black crusts have also been investigated by SEM-EDS. Figure 4 reports BSE images of black crusts from the surface of the limestone “vacuolar” L5, Rosso Ammonitico Veronese L14 and Marmor Proconnesium L16. They are formed by an association of lamellar gypsum crystals perpendicular to the supporting surface. In the interstices between crystals are entrapped carbon particles, quartz-feldspar grains and pollen. Spherical empty particles of silica-alumina composition also occur (Fig. 4-L16), these being related to combustion processes in industrial plants (Del Monte & Sabbioni, 1983). The compositional spectrum of the black crust L14 shows that main components of gypsum (S and Ca) plus minor Si.

Fig. 4 - SEM-EDS images of black crusts developed on the surface of the limestone “vacuolar” L5, Rosso Ammonitico Veronese L14 and *Marmor Proconnesium* L16. Length of bar is 0.1 mm for the images L5 and L14 and 10 μm for the image L16. Compositional spectrum of the black crust L14. Au peak derives from sample coating.

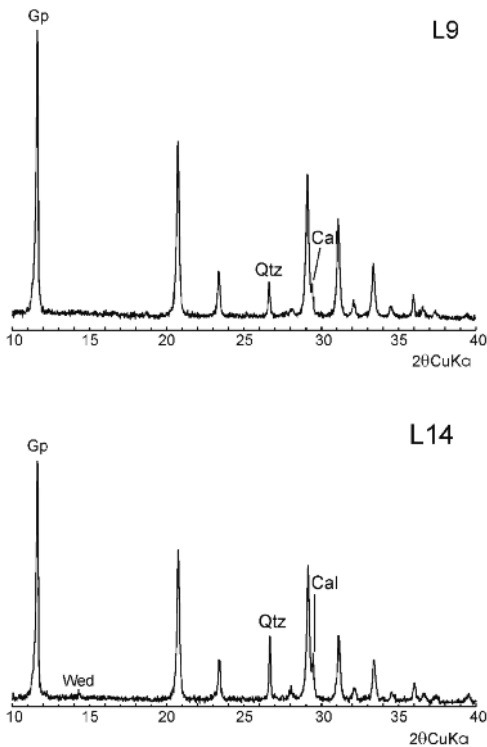
XRD investigation has been carried out on black crusts detached by the cornucopias fruits carved in limestone “vacuolar” (Fig. 2-2-L9) and from the Rosso Ammonitico Veronese slab (Fig. 2-2-L14). The analysis of XRD spectra (Fig. 5) has revealed the presence for sample L9 of abundant gypsum associated to minor calcite and quartz and for sample L14 of abundant gypsum associated to calcite, quartz and traces of weddellite (bihydrated calcium oxalate).

Fig. 5 - XRD patterns of the black crusts developed on the surface of limestone “vacuolar” L9 and of the Rosso Ammonitico Veronese L14. The main peaks corresponding to the identified minerals were labelled as follows. Gp: Gypsum; Cal: Calcite; Qtz: Quartz; Wed: Weddellite. Mineral abbreviations are after Kretz (1983) except Weddellite.

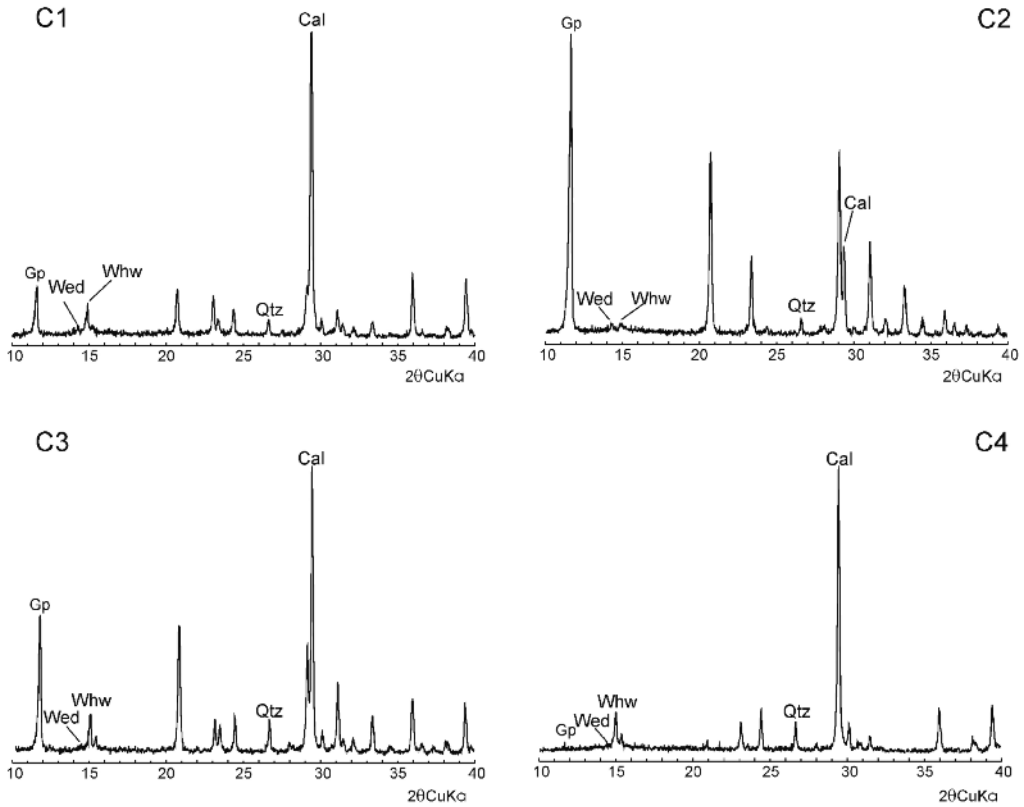
Orsera and limestone “facies liburnica” (E). Some patina also occur in the higher part of the granite columns below the marble capitals. We noticed that black crusts cover most of the patinas. In order to assess the composition of the patinas, we performed XRD analyses reported in Figure 6. The patinas have been gently scraped from the stone surface trying to avoid the detachment of the black crusts and of the host material. Samples C1 and C3 come from the surface of the Pietra d’Istria-Orsera, sample C2 from the surface of the Rosso Ammonitico Veronese and sample C4 from the surface of limestone “facies liburnica”. We observe that in

all the investigated samples both whewellite (monohydrated calcium oxalate) and weddellite (bihydrated calcium oxalate) occur. Calcite occurs on some portions of the calcareous substratum, gypsum on the black crusts and quartz from solid particles.

Fig. 6 - XRD patterns of the Ca-oxalates patinas developed on the surface of the Pietra d'Istria-Orsera C1, C3, of the Rosso Ammonitico Veronese C2 and of the limestone "facies liburnica" C4. The main peaks corresponding to the identified minerals were labelled as follows. Gp: Gypsum; Cal: Calcite; Qtz: Quartz; Wed: Weddellite; Whw: Whewellite. Mineral abbreviations are after Kretz (1983) except Weddellite and Whewellite.

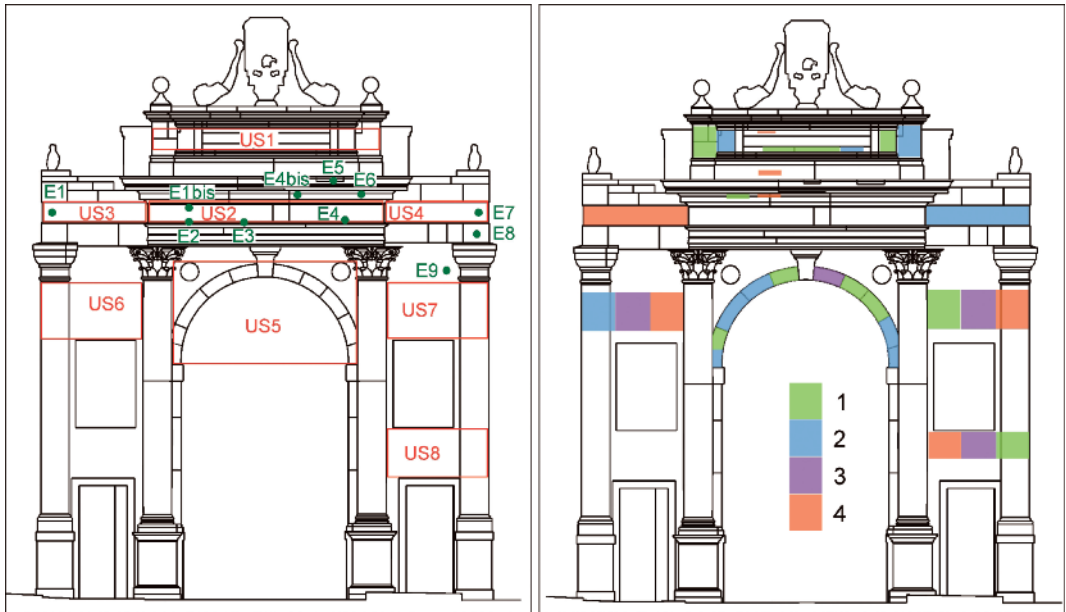
Gate. In places, apparently without any direct connection, ashlar stones or pieces of walls show deep deterioration with discontinuities and fissurations. In other places, the walls look disconnected (Fig. 7).

Fig. 7 - (A) Location of ashlar stones, dimension stones and hanging walls investigated with ultrasound microseismicity (US1-US8) and point of endoscopic inspections (E1-E9). (B) Results of ultrasound microseismicity: 1 good preservation state; 2 surficial deterioration; 3 surficial to deep deterioration; 4 deep deterioration.

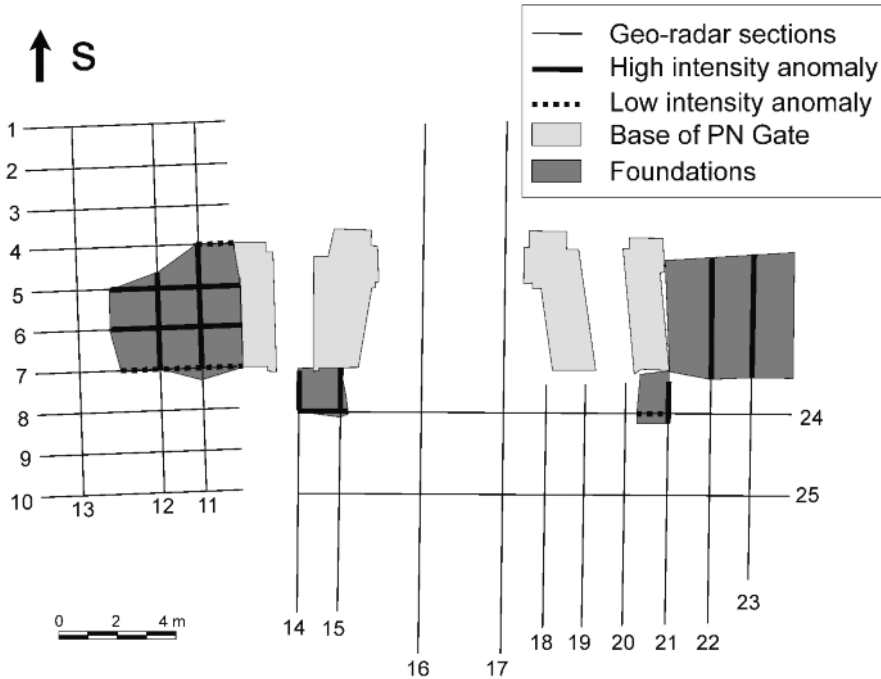
Fig. 8 - Location of georadar sections of the Porta Nuova area.

The georadar profiles of the first 3-metre underground have shown in detail the good conditions of the foundations and their continuation at both sides of the Gate (Fig. 8).
