Mapping and characterization of stone materials and their alteration/deterioration products in the historical center of Palermo (Italy)

ABSTRACT. — In the last years, natural and man-made building materials from several important historical palaces and/or churches of Palermo (Italy) and their alteration/deterioration products started to be collected and analyzed.

In this paper are reported the relief and digital mapping of stone material's typology and conservation state of the Baroque palaces *Lungarini* (XVII century), *Alliata di Villafranca* (XVIII century), *Ugo delle Favare* (XVIII century) and the church of *Santa Maria dei Miracoli* (XVI century), all located in the historical center of the city. The results of mineralogical-petrographic analysis performed on the original building materials and their alteration/deterioration products are also discussed.

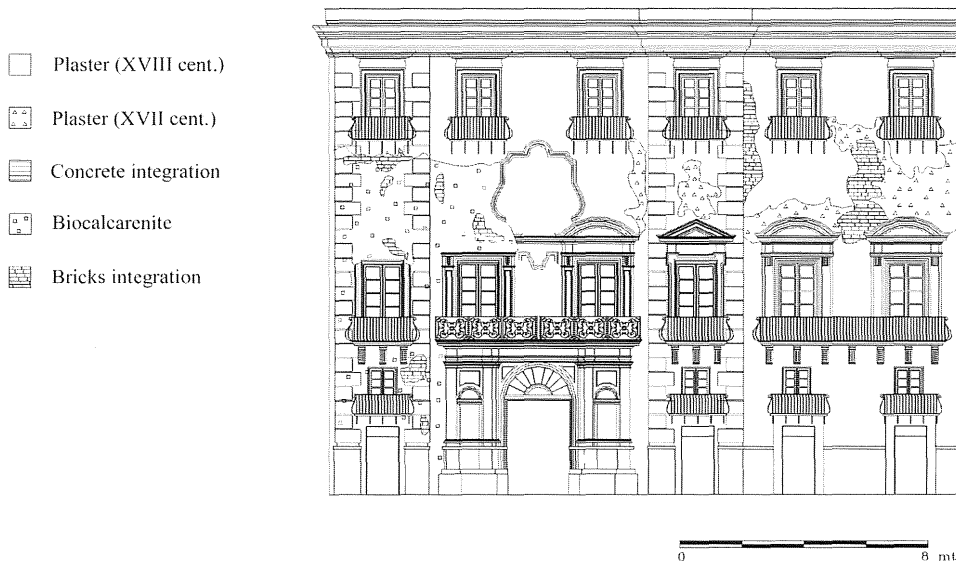
Lungarini Palace

The three Baroque palaces resulted characterized by the employ of the similar building materials. Figures 1a and 1b show, as example, the digitalized relieves referred to *Lungarini* and *Alliata di Villafranca* palaces. The load-bearing walls are composed of squared blocks of the local porous Pleistocene biocalcarene. They show only slight macroscopic differences, from place to place, which can be easily explained considering the use of the same lithotype although exploited in different quarries of Palermo's territory. The wall structure is constantly covered by one or two layers of plaster, whitish or light pinkish in color. The biocalcarene is in full sight only in the balcony where constitutes brackets, members and various decorative sculptures. Monolithic columns decorating the main gate and their plinths are manufactured, in most of the cases, with a local hard gray limestone (breccias) of Mesozoic age, locally named *pietra di Billiemi*. More or less recent

Fig. 1 – Mapping of natural and man-made building materials employed in the main façades of *Lungarini* and *Alliata di Villafranca* palaces.

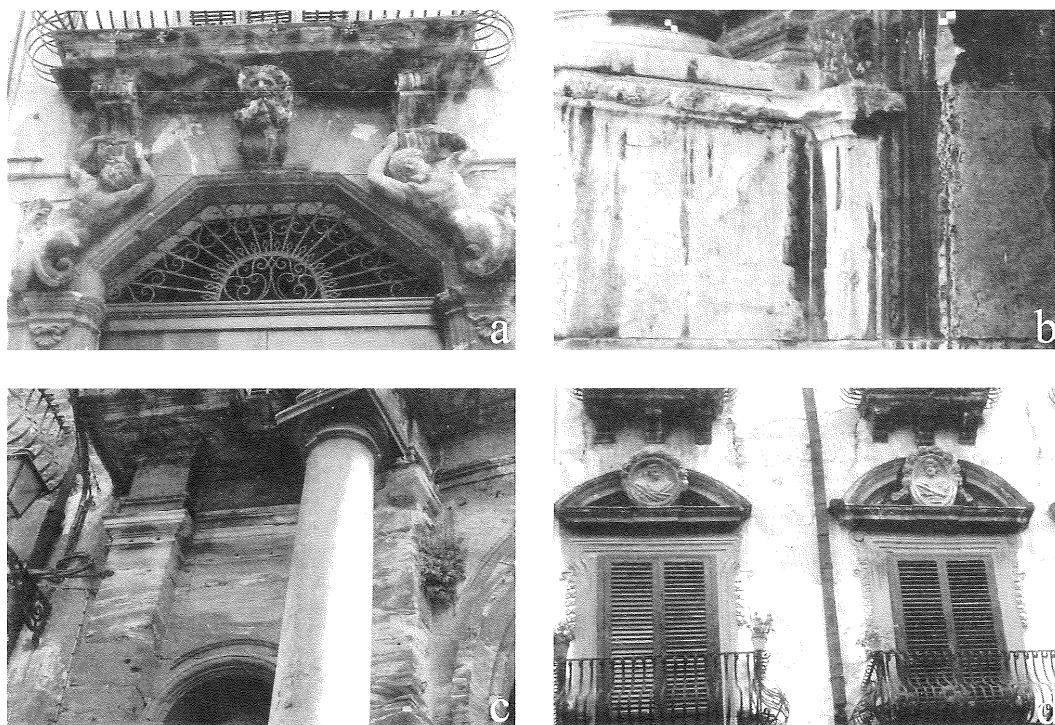
- *black crusts*: are mostly concentrated on the surfaces of the building repaired from the washing-action of rain waters (fig. 2a). They show variable thickness and morphologic characteristics according to the nature of the stone to which they adhere tenaciously. When spontaneously detached the substratum appears to be strongly disaggregated.

- *brownish-blackish films*: show small thickness and preferentially develop on compact materials (fig. 2b). They can be removed from the substratum which generally remains integral.

- *differential degradation*: is in close relationship with the compositional or textural heterogeneity of the building material, resulting particularly evident in the calcarenite (fig. 2c).

- *gaps*: are due to loss of parts of the surface plaster which brings to light the inner stone substratum (fig. 2d).

Fig. 2 – (a) *Ugo delle Favare* palace (XVII century): soluble salt efflorescences and black crusts; (b) *Alliata di Villafranca* palace (XVIII century) brownish-black films on *Billiemi* limestone; (c) *Alliata di Villafranca* palace (XVIII century) examples of black crusts and differential degradation in the biocalcarenite; (d) *Lungarini* Palace: detachment of the XVIII century plaster bringing to light the older one (XVII century) decorated with a painted «diamond» ashlar-work.

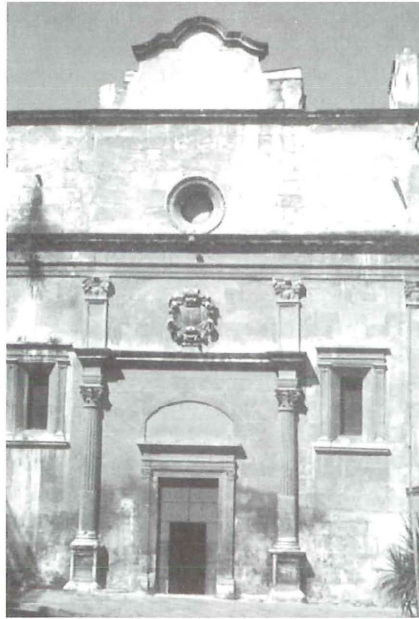
The main prospect of the church of *Santa Maria dei Miracoli* has been realized with a whitish Pleistocene biocalcarene, very probably exploited in the north zone of Palermo. The whole façade is covered by an ocher film. The decorative elements are also made of calcarenite, with the exception for a coat of arms realized in marble (fig. 3). It has to be noticed that the upper part of the building has been realized in a successive age (XVIII

- *patina*: all the wall surface of the main façade is covered by an ocher patina which alters the original color of the stone material. This is evident in the parts subjected to washing processes, in which it can be noted the original color of the stone;

Fig. 3 – Image of the main façade of the church of *Santa Maria dei Miracoli* (XVI century) showing the different types of biocalcarenite (upper and lower orders) and the ocher film.

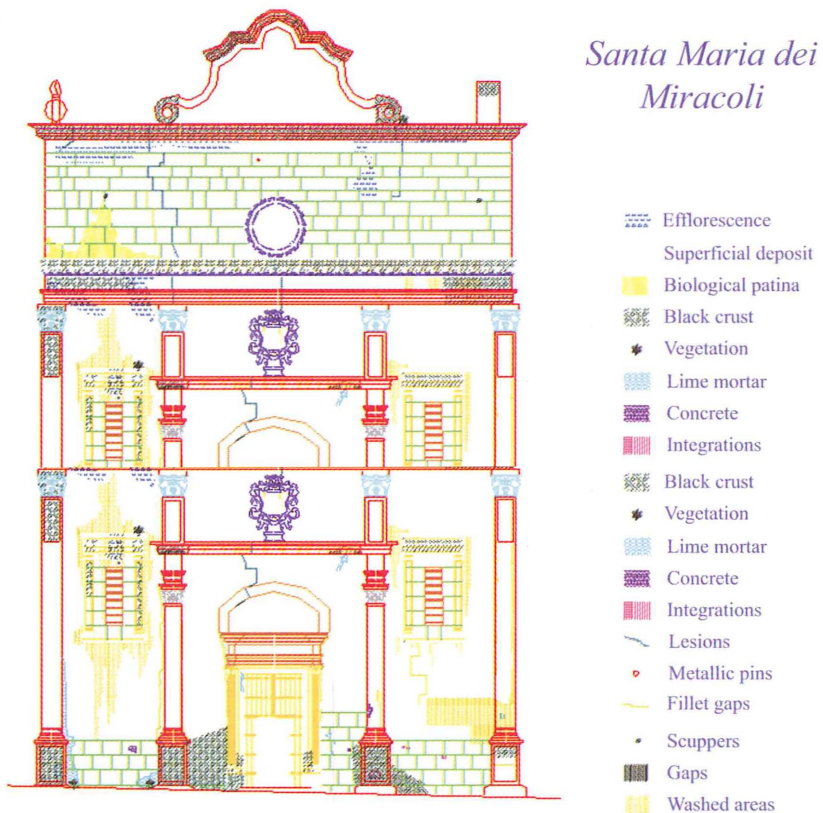
In this building, from the examination of the state of the defects emerges a general picture in which the hardest degradations are related to humidity (capillary infiltrations) and therefore to the formation of soluble salts, as well as to environmental pollution and biological factors. Recognition of the defects by the photogrammetric relief has been processed in a graphical table according to the recommendation ICR/CNR Normal 1/88, allowing an immediate and synchronic reading (fig. 4). In general, most of the pathologies are very similar to those already described for the

- *loss of material*: it occurs in some parts of the façade, mainly in those jutting out of the cornices and moldings of the columns;

- *washing-effect*: Draining of rain water from the cornices and the protruding parts causes the washing away of the ocher coloring in the wall surface;

- *efflorescences*: this expression of degradation is caused by the evaporation of the water which permeates the squared blocks of

Fig. 4 – Graphic restitution of the photogrammetric relief of the church of *Santa Maria dei Miracoli* showing the state of defects.

biocalcarene, with consequent crystallization of salts towards the external surface; it is found in some zones under the cornice of the architrave, over the two pilasters and in the frame of the left window.

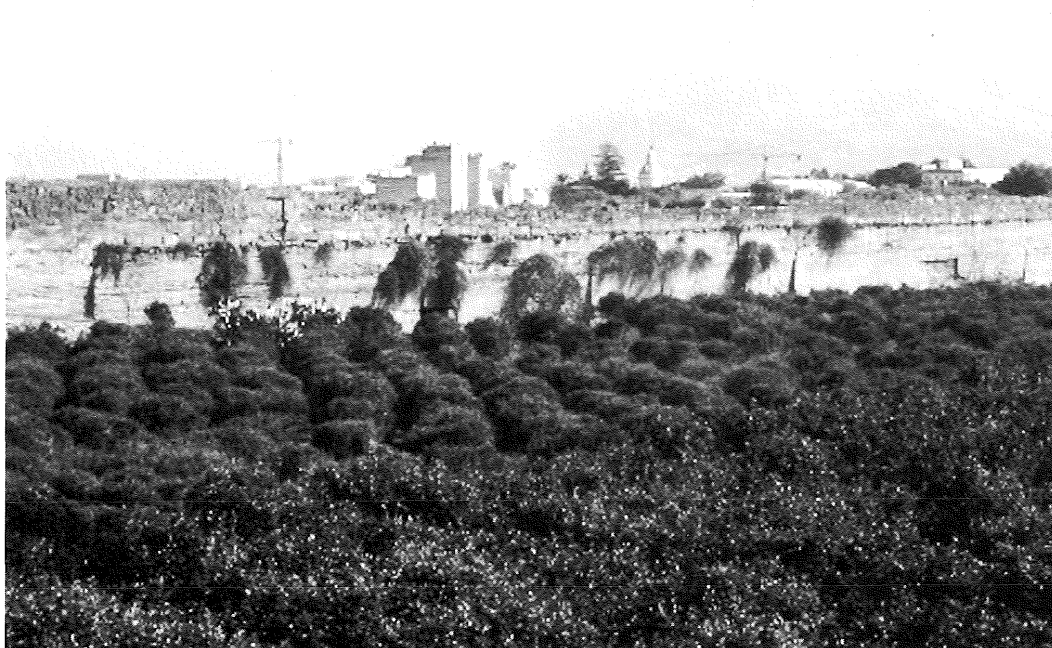
the open sky, which allowed lower costs and material waste (Todaro, 1988). The lands to be exploited were subdivided in smaller fields of rectangular shape, whose traces are still visible in the territory (fig. 5). Mining and the shaping of the blocks were carried out during summer in order to allow the porous stone to naturally dry. The squared blocks were usually left exposed two years to the atmospheric agents for being able to recognize and discard the most vulnerable ones (Cipolla, 1929).

Fig. 5 – View of the remains an ancient quarry of biocalcarenite in the surroundings of Palermo (*Aspra*).
